New-build snagging report by Alex Morgan

# Plot 24, Willow Gardens

| REFERENCE<br>DEMO-NB-024 | VISIT DATE<br>Tue, 8 Sept 2026 | SURVEYOR<br>Alex Morgan |

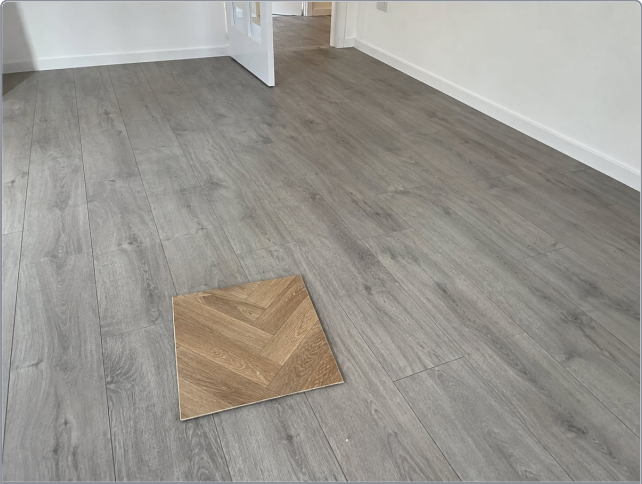
PHOTO 1.1

**Defect.** Grey straight-laid planks have been fitted. The homeowner confirmed warm oak parquet as the selected finish and showed the approved sample during the visit.

- 1.1** Entrance hall Grey straight-laid planks have been fitted. The homeowner confirmed warm oak parquet as the selected finish and showed the approved sample during the visit.

**Action.** Check the recorded selection with the homeowner and replace the hall flooring with the agreed finish and laying pattern before handover.

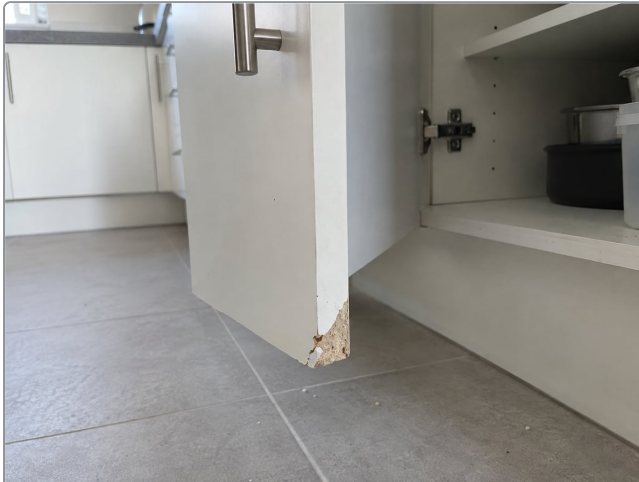
PHOTO 2.1

**Defect.** The lower outer corner of the white base-unit door is broken away, exposing the chipboard core.

| 2.1 | Kitchen | The lower outer corner of the white base-unit door is broken away, exposing the chipboard core. |

**Action.** Replace the damaged door with a matching door and check its alignment, opening and closing before handover.

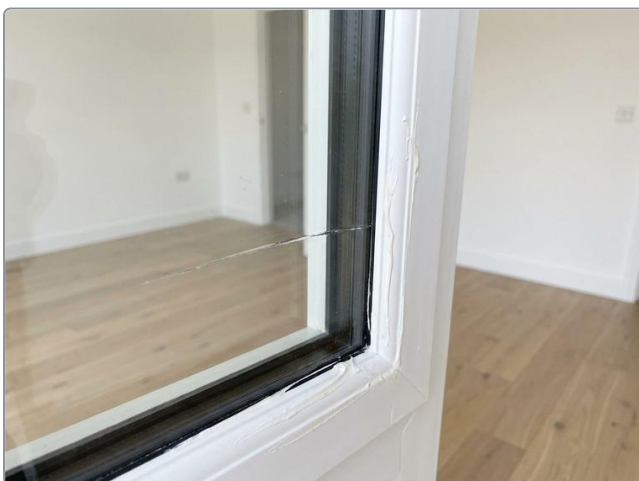
PHOTO 3.1

**Defect.** A long scratch is visible across the window glass at mid-height in daylight.

| 3.1 | Living room | A long scratch is visible across the window glass at mid-height in daylight. |

**Action.** Ask the glazing contractor to assess the scratch and rectify it or replace the affected pane. Check the finished glass in daylight before handover.

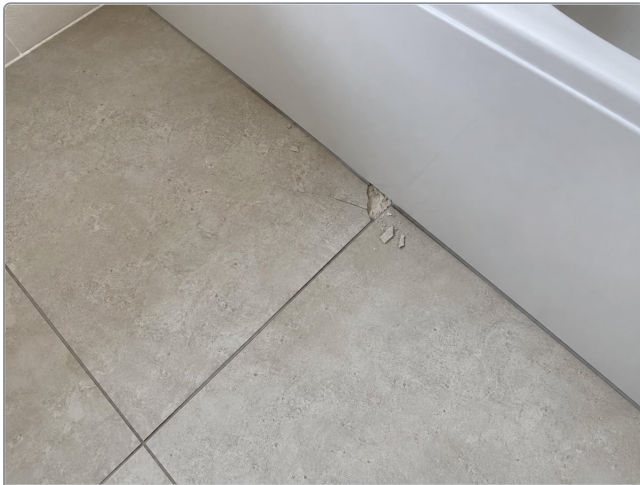
PHOTO 4.1

**Defect.** A floor tile is cracked and chipped, with a piece missing from the damaged edge.

| 4.1 | Bathroom | A floor tile is cracked and chipped, with a piece missing from the damaged edge. |

**Action.** Replace the damaged tile with a matching tile and finish the surrounding grout neatly before handover.

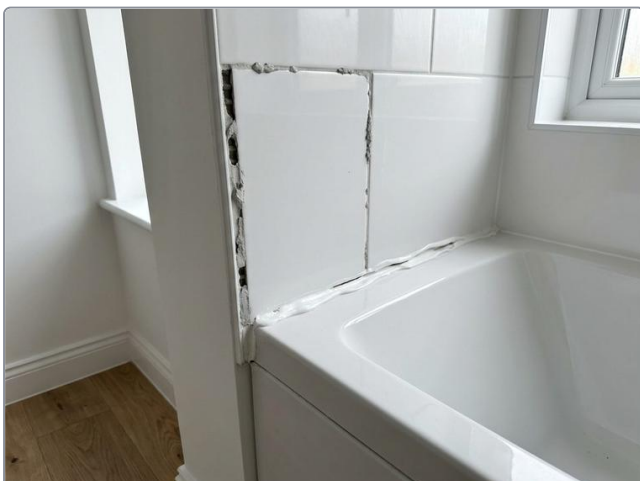
PHOTO 4.2

**Defect.** The wall-tile joints beside the bath are incomplete, with open gaps in the grout.

| 4.2 | Bathroom | The wall-tile joints beside the bath are incomplete, with open gaps in the grout. |

**Action.** Prepare and grout the unfinished joints, then clean the tile faces and check for remaining gaps.

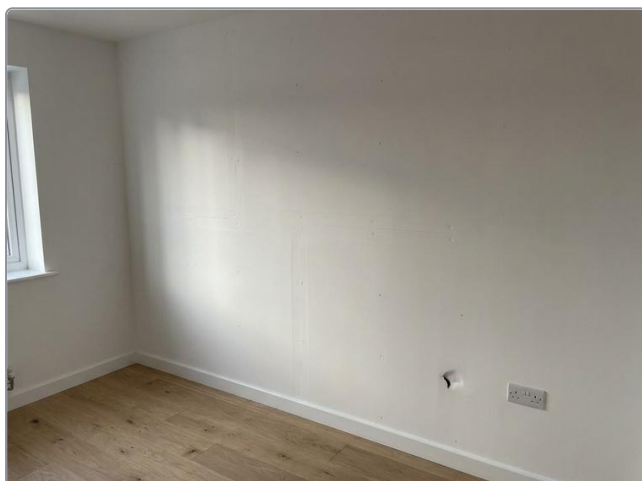
PHOTO 5.1

**Defect.** Horizontal and vertical plasterboard joints remain visible through the paint, with patchy areas apparent in light from the window.

| 5.1 | Main bedroom | Horizontal and vertical plasterboard joints remain visible through the paint, with patchy areas apparent in light from the window. |

**Action.** Prepare and finish the affected joints to an even surface, then redecorate the wall and inspect it in natural light.

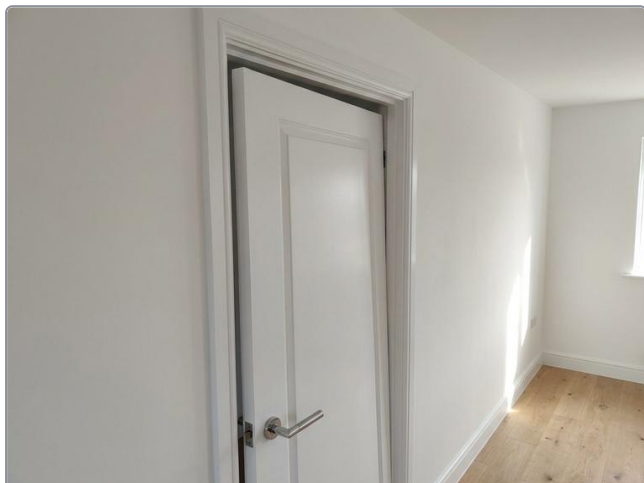
PHOTO 6.1

**Defect.** The bedroom door remained proud of the frame and did not latch when the handle was released during the operation check.

| 6.1 | Bedroom 2 | The bedroom door remained proud of the frame and did not latch when the handle was released during the operation check. |

**Action.** Check and adjust the door, hinges and latch so it closes freely and latches without being forced. Make good any disturbed finish.

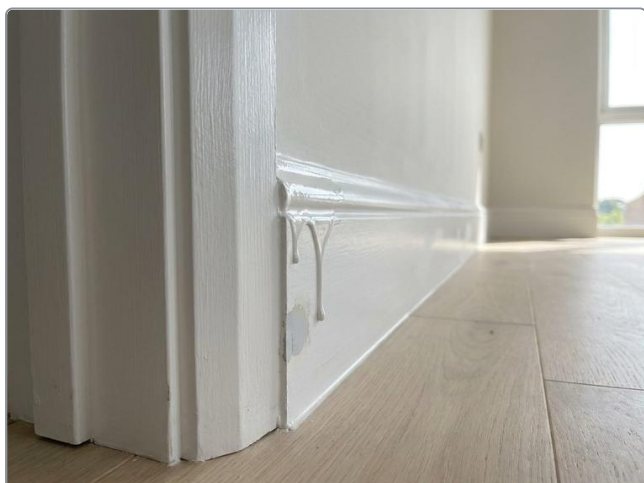
PHOTO 6.2

**Defect.** Raised paint runs and drips remain on the skirting beside the door architrave.

| 6.2 | Bedroom 2 | Raised paint runs and drips remain on the skirting beside the door architrave. |

**Action.** Remove the runs, prepare the surface and repaint the affected skirting to a smooth, even finish.

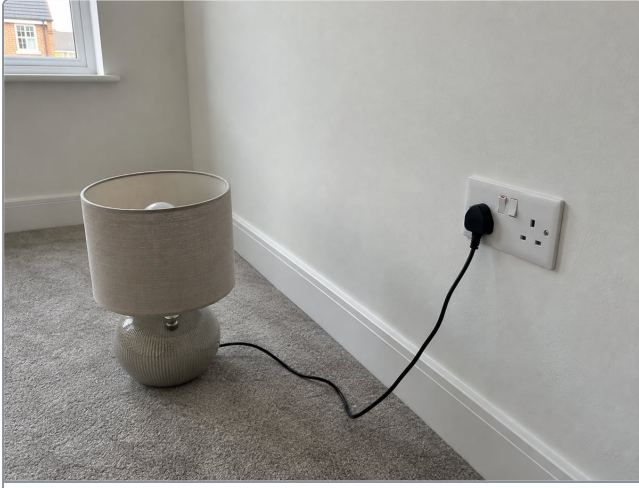
PHOTO 7.1

**Defect.** A lamp that worked at a neighbouring socket did not illuminate from either outlet of the low-level double socket beside the window, with the socket switches on.

- 7.1** Landing A lamp that worked at a neighbouring socket did not illuminate from either outlet of the low-level double socket beside the window, with the socket switches on.

**Action.** Ask a qualified electrician to investigate, rectify the fault and verify operation before handover. No cause has been established by this functional check.

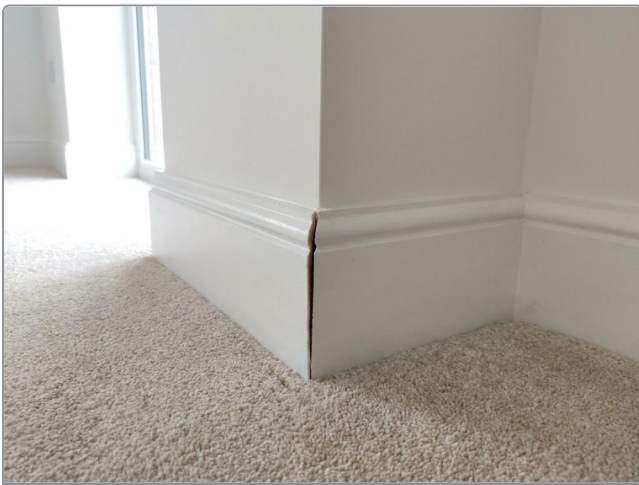
PHOTO 7.2

**Defect.** The outside-corner mitre joint in the skirting is open, with an unfinished gap between the two sections.

| 7.2 | Landing | The outside-corner mitre joint in the skirting is open, with an unfinished gap between the two sections. |

**Action.** Refit the corner joint so the sections meet neatly, then make good the painted finish.

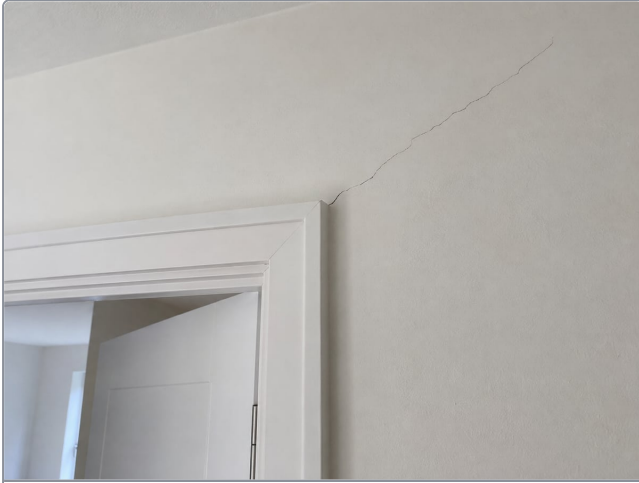
PHOTO 7.3

**Defect.** A fine diagonal crack runs through the painted plaster above the upper corner of the door opening.

| 7.3 | Landing | A fine diagonal crack runs through the painted plaster above the upper corner of the door opening. <b>MONITOR</b> |

**Action.** Record and monitor the crack. Ask the builder to review any change before a cosmetic repair is agreed.
