New-construction punch list by Alex Morgan

Plot 24, Willow Gardens

| REFERENCE<br>DEMO-NB-024 | VISIT DATE<br>Tue, Sep 8, 2026 | SURVEYOR<br>Alex Morgan |

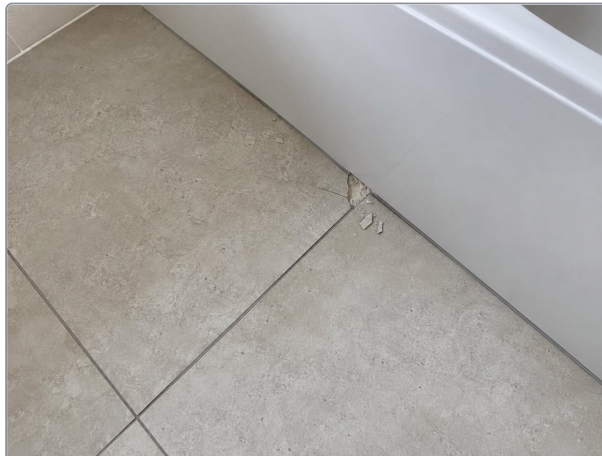
PHOTO 4.1

**Defect.** A floor tile is cracked and chipped, with a piece missing from the damaged edge.

| <b>4.1</b> Bathroom | A floor tile is cracked and chipped, with a piece missing from the damaged edge. |

**Action.** Replace the damaged tile with a matching tile and finish the surrounding grout neatly before handover.

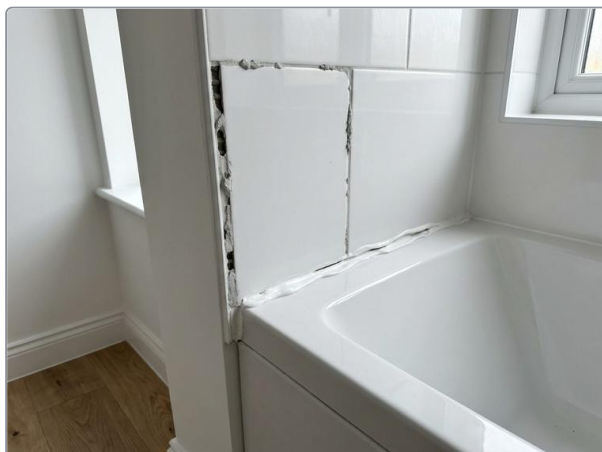
PHOTO 4.2

**Defect.** The wall-tile joints beside the tub are incomplete, with open gaps in the grout.

| <b>4.2</b> Bathroom | The wall-tile joints beside the tub are incomplete, with open gaps in the grout. |

**Action.** Prepare and grout the unfinished joints, then clean the tile faces and check for remaining gaps.

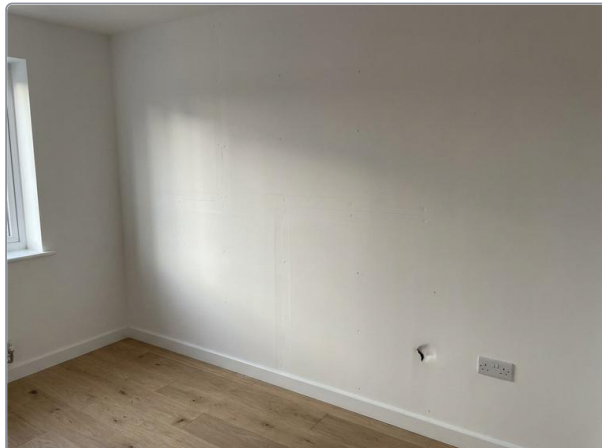
PHOTO 5.1

**Defect.** Horizontal and vertical drywall joints remain visible through the paint, with patchy areas apparent in light from the window.

| <b>5.1</b> Primary bedroom | Horizontal and vertical drywall joints remain visible through the paint, with patchy areas apparent in light from the window. |

**Action.** Prepare and finish the affected joints to an even surface, then repaint the wall and inspect it in natural light.
