Snagging list by Alex Morgan

# Plot 24, Willow Gardens

| REFERENCE<br>DEMO-NB-024 | VISIT DATE<br>Tue, 8 Sept 2026 | SURVEYOR<br>Alex Morgan |

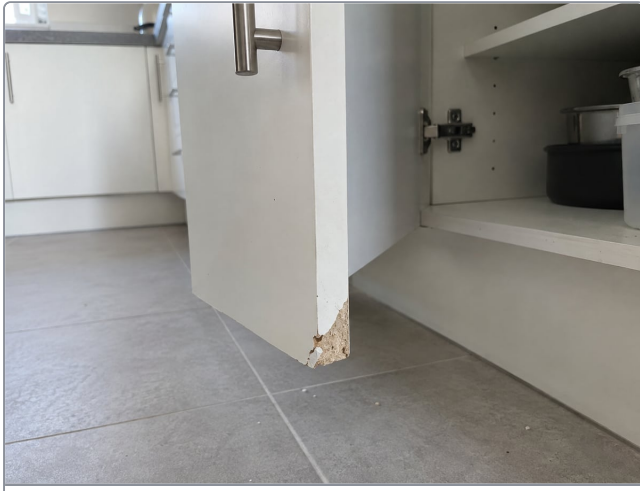
PHOTO 2.1

**Defect.** The lower outer corner of the white base-unit door is broken away, exposing the chipboard core.

| 2.1 | Kitchen | The lower outer corner of the white base-unit door is broken away, exposing the chipboard core. |

**Action.** Replace the damaged door with a matching door and check its alignment, opening and closing before handover.

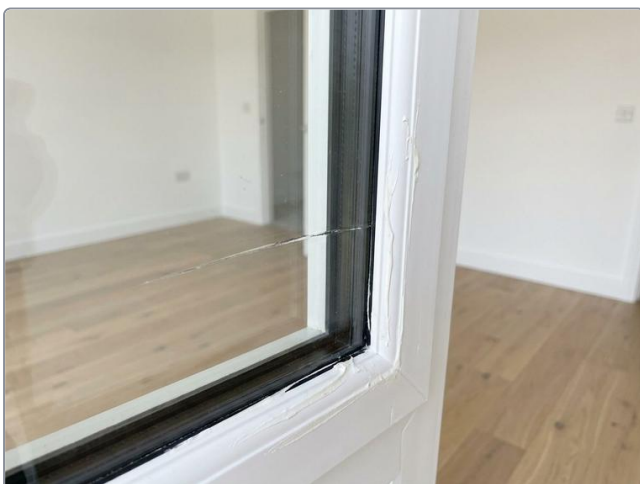
PHOTO 3.1

**Defect.** A long scratch is visible across the window glass at mid-height in daylight.

| 3.1 | Living room | A long scratch is visible across the window glass at mid-height in daylight. |

**Action.** Ask the glazing contractor to assess the scratch and rectify it or replace the affected pane. Check the finished glass in daylight before handover.

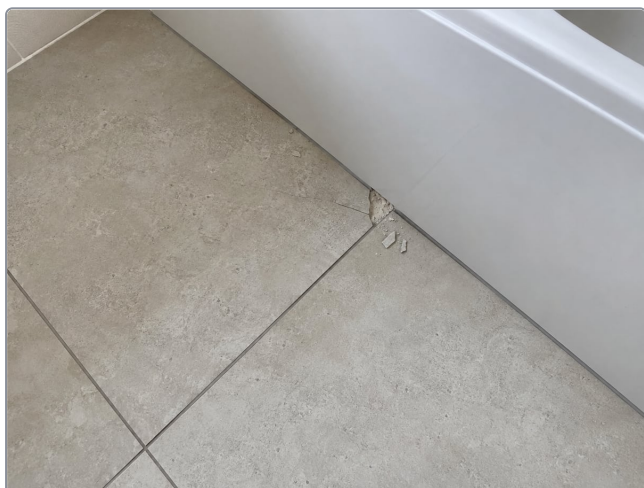
PHOTO 4.1

**Defect.** A floor tile is cracked and chipped, with a piece missing from the damaged edge.

| 4.1 | Bathroom | A floor tile is cracked and chipped, with a piece missing from the damaged edge. |

**Action.** Replace the damaged tile with a matching tile and finish the surrounding grout neatly before handover.

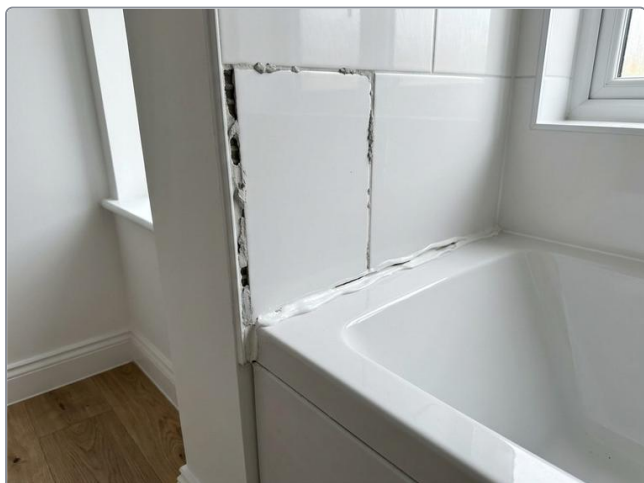
PHOTO 4.2

**Defect.** The wall-tile joints beside the bath are incomplete, with open gaps in the grout.

| 4.2 | Bathroom | The wall-tile joints beside the bath are incomplete, with open gaps in the grout. |

**Action.** Prepare and grout the unfinished joints, then clean the tile faces and check for remaining gaps.

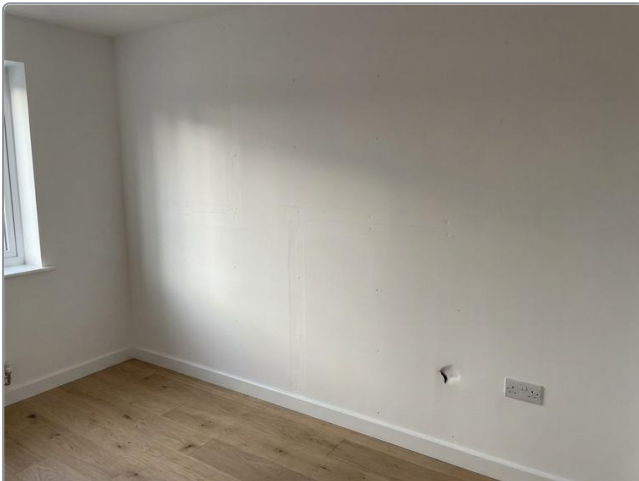
PHOTO 5.1

**Defect.** Horizontal and vertical plasterboard joints remain visible through the paint, with patchy areas apparent in light from the window.

| 5.1 | Main bedroom | Horizontal and vertical plasterboard joints remain visible through the paint, with patchy areas apparent in light from the window. |

**Action.** Prepare and finish the affected joints to an even surface, then redecorate the wall and inspect it in natural light.

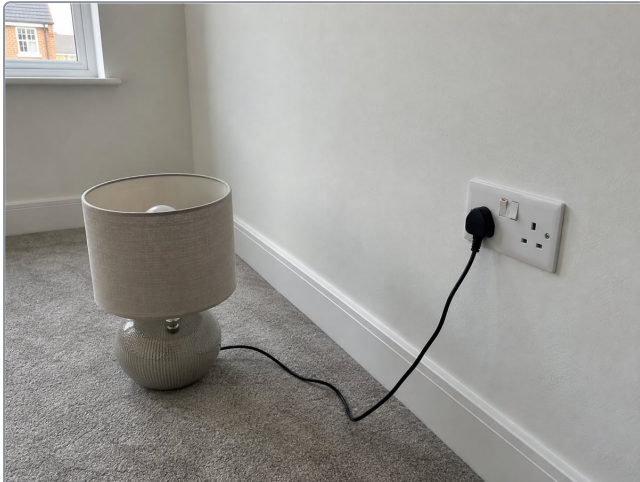
PHOTO 7.1

**Defect.** A lamp that worked at a neighbouring socket did not illuminate from either outlet of the low-level double socket beside the window, with the socket switches on.

- 7.1** Landing A lamp that worked at a neighbouring socket did not illuminate from either outlet of the low-level double socket beside the window, with the socket switches on.

**Action.** Ask a qualified electrician to investigate, rectify the fault and verify operation before handover. No cause has been established by this functional check.

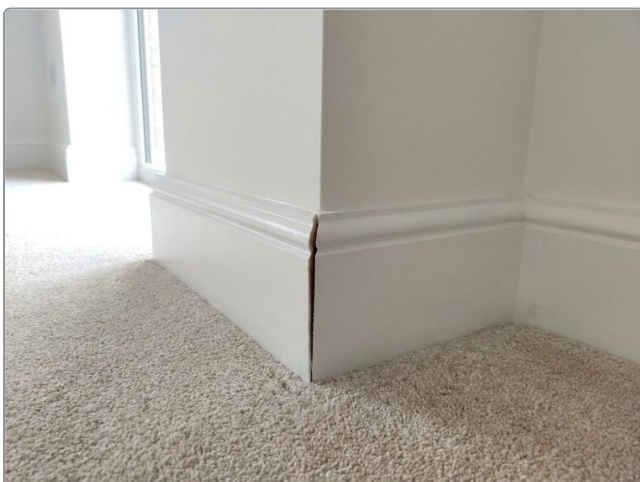
PHOTO 7.2

**Defect.** The outside-corner mitre joint in the skirting is open, with an unfinished gap between the two sections.

| 7.2 | Landing | The outside-corner mitre joint in the skirting is open, with an unfinished gap between the two sections. |

**Action.** Refit the corner joint so the sections meet neatly, then make good the painted finish.

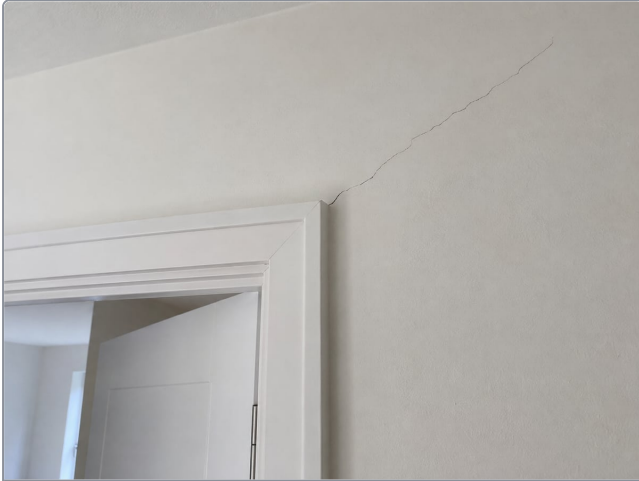
PHOTO 7.3

**Defect.** A fine diagonal crack runs through the painted plaster above the upper corner of the door opening.

| 7.3 | Landing | A fine diagonal crack runs through the painted plaster above the upper corner of the door opening. <b>MONITOR</b> |

**Action.** Record and monitor the crack. Ask the builder to review any change before a cosmetic repair is agreed.
