Punch list by Alex Morgan

# Plot 24, Willow Gardens

| REFERENCE<br>DEMO-NB-024 | VISIT DATE<br>Tue, Sep 8, 2026 | SURVEYOR<br>Alex Morgan |

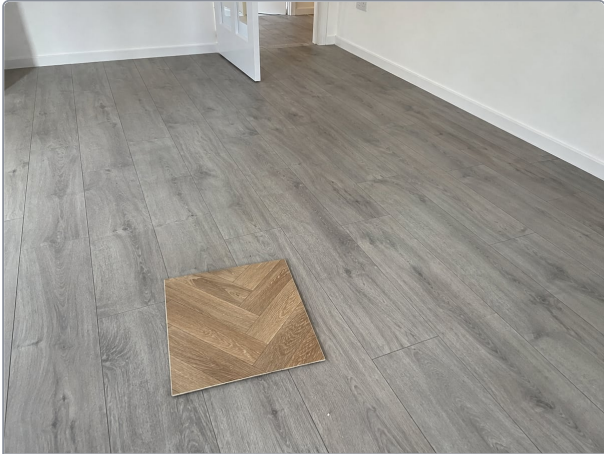
PHOTO 1.1

**Defect.** Gray straight-laid planks have been installed. The homeowner confirmed warm oak parquet as the selected finish and showed the approved sample during the visit.

- 1.1** Entry hall Gray straight-laid planks have been installed. The homeowner confirmed warm oak parquet as the selected finish and showed the approved sample during the visit.

**Action.** Check the recorded selection with the homeowner and replace the hall flooring with the agreed finish and installation pattern before handover.

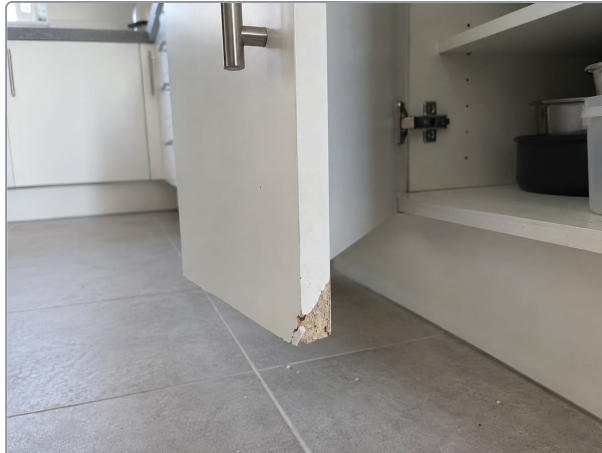
PHOTO 2.1

**Defect.** The lower outer corner of the white base-cabinet door is broken away, exposing the particleboard core.

| <b>2.1</b> Kitchen | The lower outer corner of the white base-cabinet door is broken away, exposing the particleboard core. |

**Action.** Replace the damaged door with a matching door and check its alignment, opening and closing before handover.

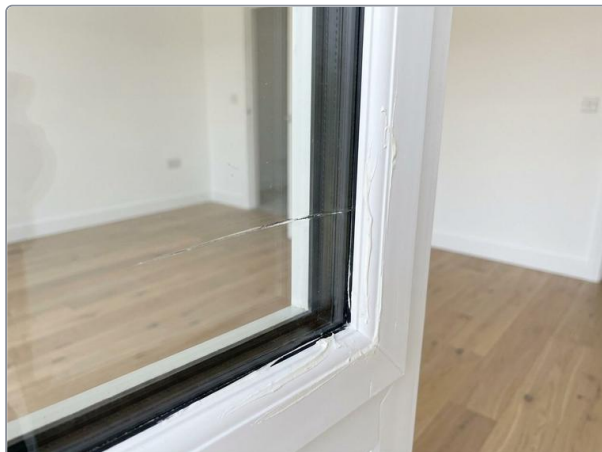
PHOTO 3.1

**Defect.** A long scratch is visible across the window glass at mid-height in daylight.

| <b>3.1</b> Living room | A long scratch is visible across the window glass at mid-height in daylight. |

**Action.** Ask the glazing contractor to assess the scratch and correct it or replace the affected pane. Check the finished glass in daylight before handover.

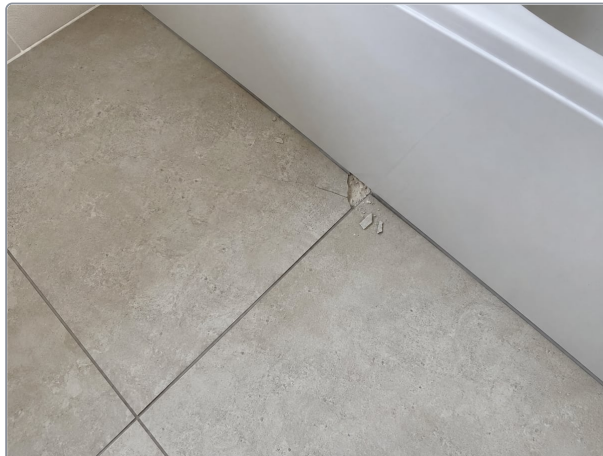
PHOTO 4.1

**Defect.** A floor tile is cracked and chipped, with a piece missing from the damaged edge.

| <b>4.1</b> Bathroom | A floor tile is cracked and chipped, with a piece missing from the damaged edge. |

**Action.** Replace the damaged tile with a matching tile and finish the surrounding grout neatly before handover.

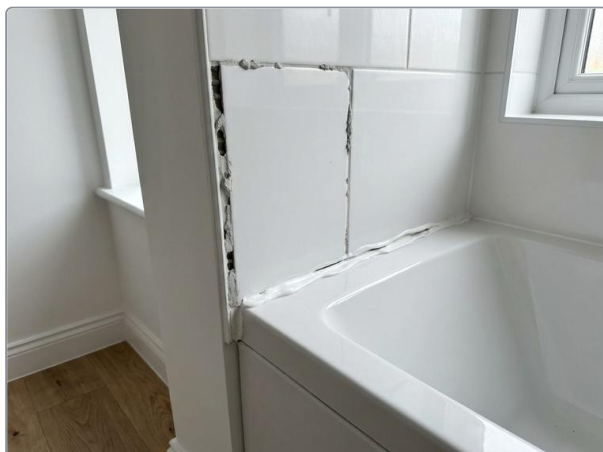
PHOTO 4.2

**Defect.** The wall-tile joints beside the tub are incomplete, with open gaps in the grout.

| <b>4.2</b> Bathroom | The wall-tile joints beside the tub are incomplete, with open gaps in the grout. |

**Action.** Prepare and grout the unfinished joints, then clean the tile faces and check for remaining gaps.

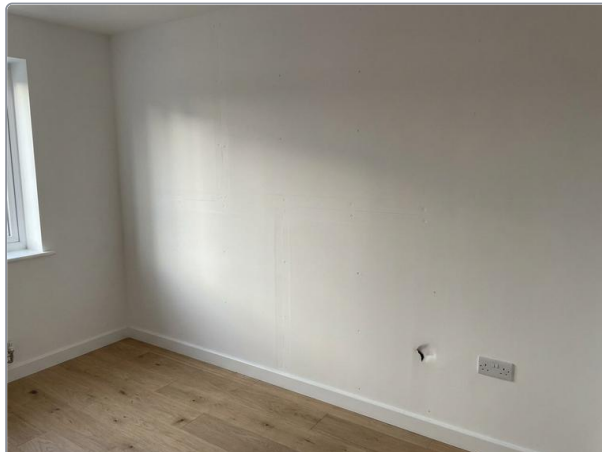
PHOTO 5.1

**Defect.** Horizontal and vertical drywall joints remain visible through the paint, with patchy areas apparent in light from the window.

| <b>5.1</b> Primary bedroom | Horizontal and vertical drywall joints remain visible through the paint, with patchy areas apparent in light from the window. |

**Action.** Prepare and finish the affected joints to an even surface, then repaint the wall and inspect it in natural light.

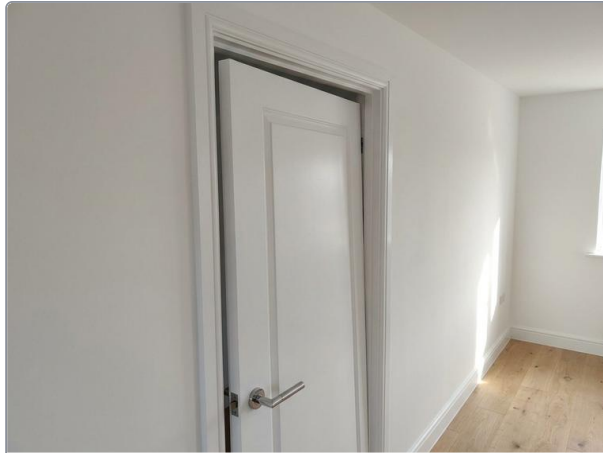
PHOTO 6.1

**Defect.** The bedroom door remained out of line with the frame and did not latch when the handle was released during the operation check.

| <b>6.1</b> Bedroom 2 | The bedroom door remained out of line with the frame and did not latch when the handle was released during the operation check. |

**Action.** Check and adjust the door, hinges and latch so it closes freely and latches without being forced. Repair any disturbed finish.

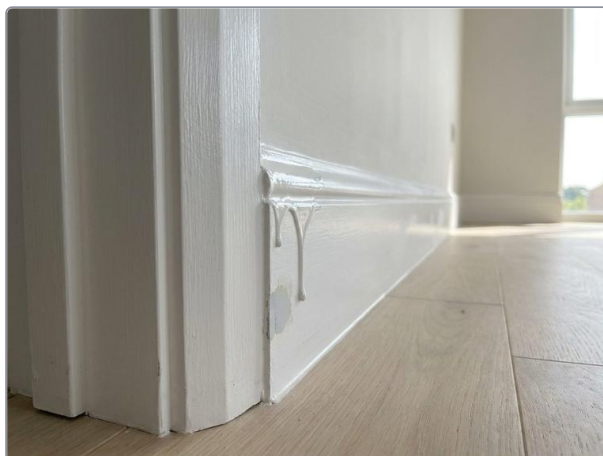
PHOTO 6.2

**Defect.** Raised paint runs and drips remain on the baseboard beside the door casing.

| <b>6.2</b> Bedroom 2 | Raised paint runs and drips remain on the baseboard beside the door casing. |

**Action.** Remove the runs, prepare the surface and repaint the affected baseboard to a smooth, even finish.

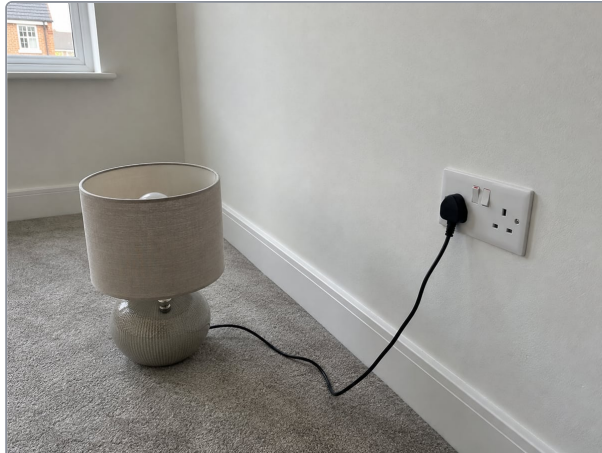
PHOTO 7.1

**Defect.** A lamp that worked at a nearby outlet did not illuminate from either receptacle of the double outlet low on the wall beside the window, with the outlet switches on.

- 7.1** Landing A lamp that worked at a nearby outlet did not illuminate from either receptacle of the double outlet low on the wall beside the window, with the outlet switches on.

**Action.** Ask a qualified electrician to investigate, correct the fault and verify operation before handover. No cause has been established by this functional check.

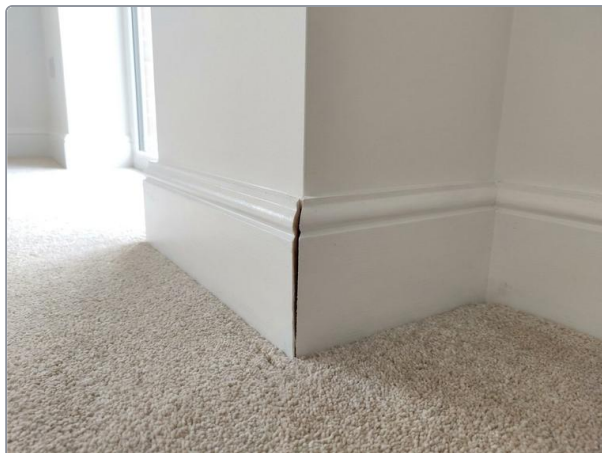
PHOTO 7.2

**Defect.** The outside-corner miter joint in the baseboard is open, with an unfinished gap between the two sections.

| <b>7.2</b> Landing | The outside-corner miter joint in the baseboard is open, with an unfinished gap between the two sections. |

**Action.** Refit the corner joint so the sections meet neatly, then repair the painted finish.

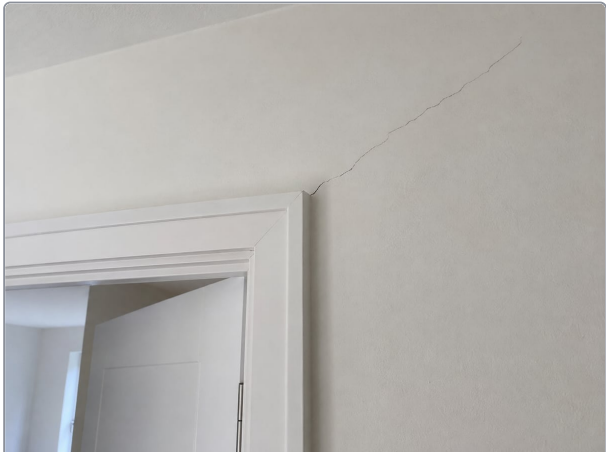
PHOTO 7.3

**Defect.** A fine diagonal crack runs through the painted finish above the upper corner of the door opening.

| <b>7.3</b> Landing | A fine diagonal crack runs through the painted finish above the upper corner of the door opening. <b>MONITOR</b> |

**Action.** Record and monitor the crack. Ask the builder to review any change before a cosmetic repair is agreed.
